St. Croix Roadside Tree Inventory and Management Strategies

Geographic Consulting, LLC

2012

St. Croix, U.S. Virgin Islands Roadside Tree Inventory and Management Strategies

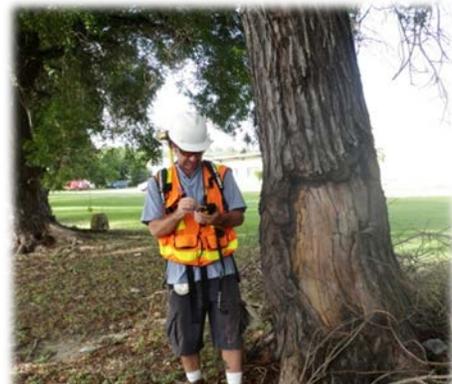
FIGURE 9. TRUNK DAMAGE, MOST LIKELY CAUSED BY A VEHICLE

Trunk Damage - Observed trunk damage was fairly evenly distributed between different sources: storm (22%), vehicle (23%), fencing (13%), machete (18%), weed eater (4%) and other (18%). The “other” category for trunk damage included co-dominant stems and included bark.

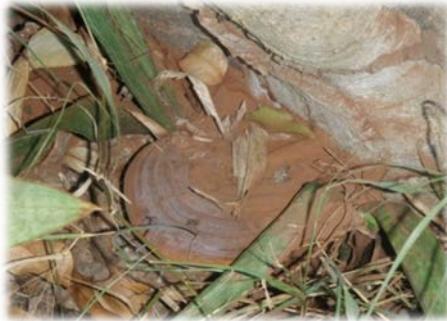
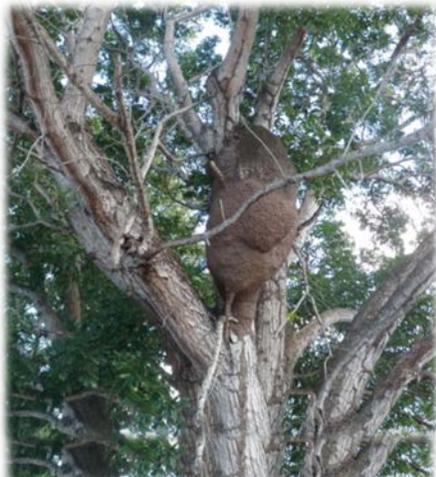
FIGURE 10. GANODERMA (ABOVE) AND A TERMITE MOUND (BELOW)

Disease signs/symptoms were mostly associated with termite nest activities (Figure 9). Major disease associated with root rot was ganoderma (*Ganoderma zonatum*). Black sooty mold, thrips, scales were other diseases observed.

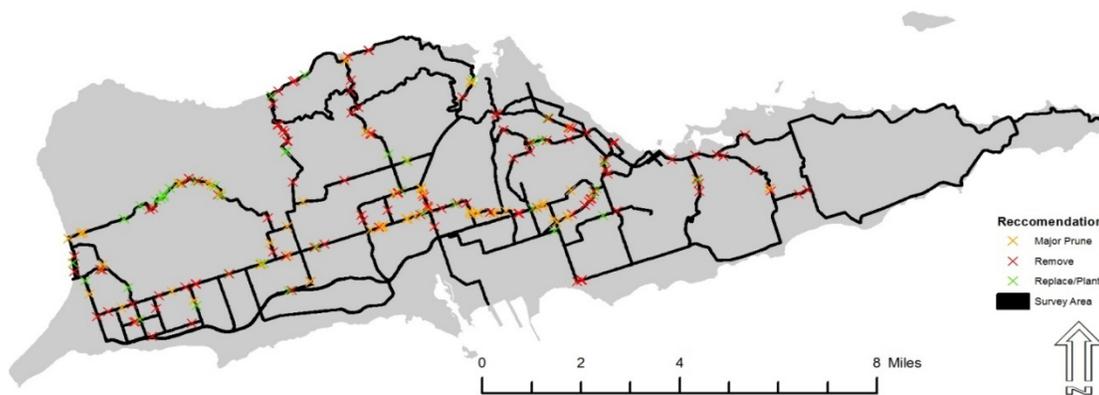
FIGURE 13: ST. CROIX U.S. VIRGIN ISLANDS PRIORITY ACTION MAP

120 Trees with major defects, very poor health and disease that should be immediately removed (44 Dead)

60 Trees in need of a major prune to mitigate hazardous conditions.

54 Trees that should be replaced with new plantings

76 Additional dead trees to be removed

Trees designated for immediate removal have both low health and are a high risk. The risk usually involves the potential for a large branch or the entire tree to fall onto a target, such as a utility, building, road or other target. These trees cannot be corrected or made safe through pruning. They are the trees most likely to fail in the short term and also at the greatest risk among the 9,929 trees in the study to fall during a storm. Removing these trees should be considered proactive storm preparation through management.
