St. Croix Roadside Tree Inventory and Management Strategies

Geographic Consulting, LLC

2012

St. Croix, U.S. Virgin Islands Roadside Tree Inventory and Management Strategies

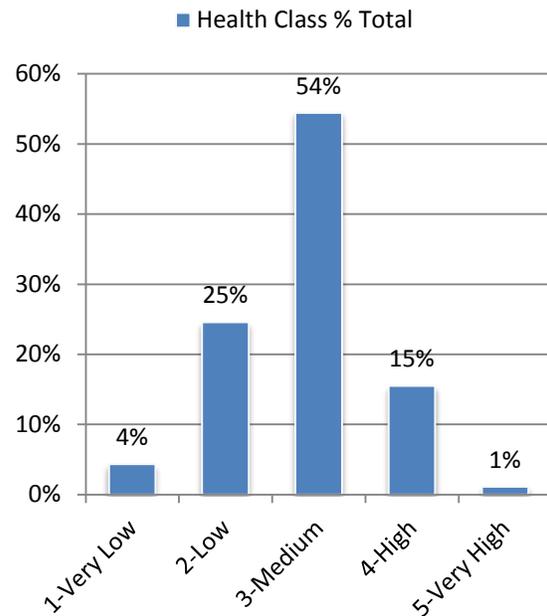
FIGURE 7: ROADSIDE TREE HEALTH CLASSIFICATION

Trees were assessed using a variety of indicators of general health and given a final health score based on the combination of the indicators (Figure 7). These health scores indicate that overall, the population is in medium health with 1% of the total population in very high health and 4% of the population with a very low health score.

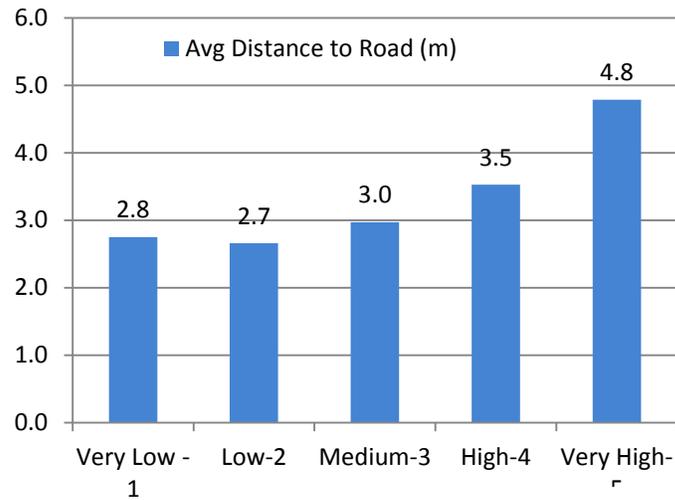
FIGURE 11. AVERAGE HEALTH SCORE OF ROADSIDE TREES IN RELATION TO DISTANCE FROM ROAD

Not surprisingly, trees that were closer to the road, on average, were in poorer overall health than those that were farther from the road. (Figure 11).

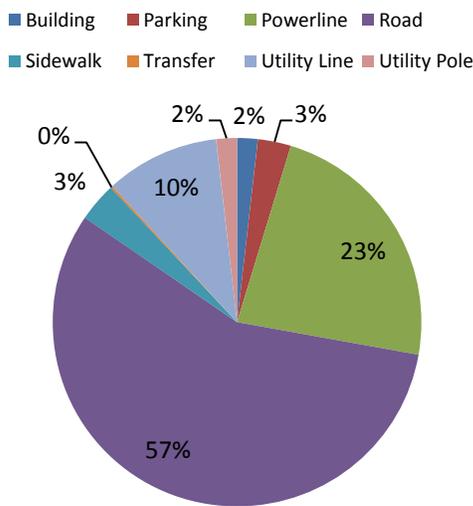
When a tree was identified with hazard potential, the targets were identified for each tree. The most common target was the road itself followed by power lines. Other targets included buildings, parking areas, sidewalks, transformers, utility lines and utility poles (Figure 12).

Trees that are making direct contact with a target are considered “in conflict” with the target. 1932 trees were in conflict with utilities and 245 trees were in conflict with pavement making up 27% of the public trees surveyed.

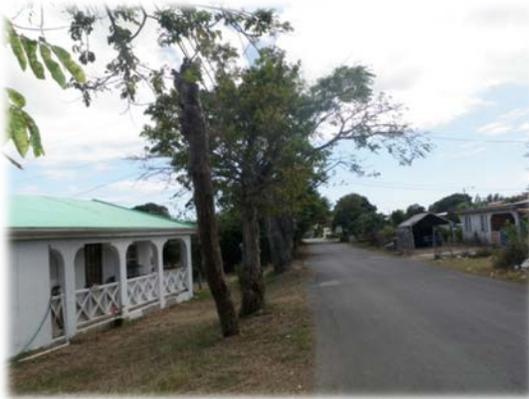
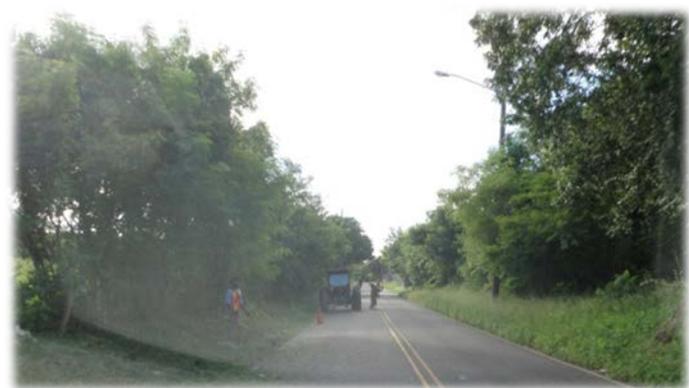
3. RURAL AND AGRICULTURAL AREAS – Generally rural roadside vegetation and urban roadside trees and vegetation are managed differently. Rural areas don't generally manage individual trees but try to maintain a safe right of way for vehicles to pull over and utilities to access their assets. The current practice for much of the island is to mow the right-of-way with a boom mower including small trees and limbs than intrude into the area. The area usually

covers five feet from the road edge. This method is effective in keeping drivers' line of site clear from the smaller emergent species of tan-tan (*Leucaena leucocephala*) and white manjack (*Cordia alba*) that tend to dominate these areas and grow very quickly.
